# Winfield Locks

## Failed Embedded Miter Gate Anchorage

Huntington District Corps of Engineers

Feb 2015

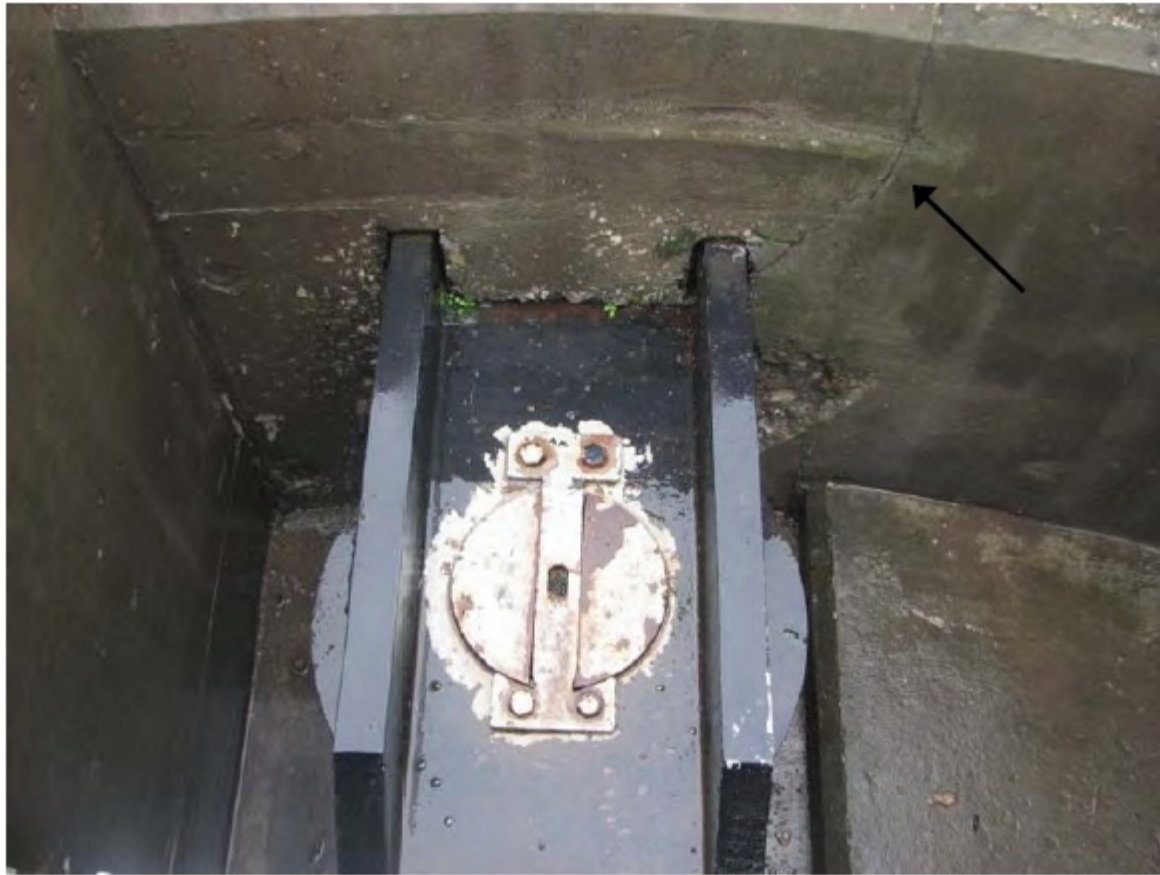
Photo 222 – Upstream River Wall Miter Gate Anchorage. Crack noted in concrete is typical at all anchorages.

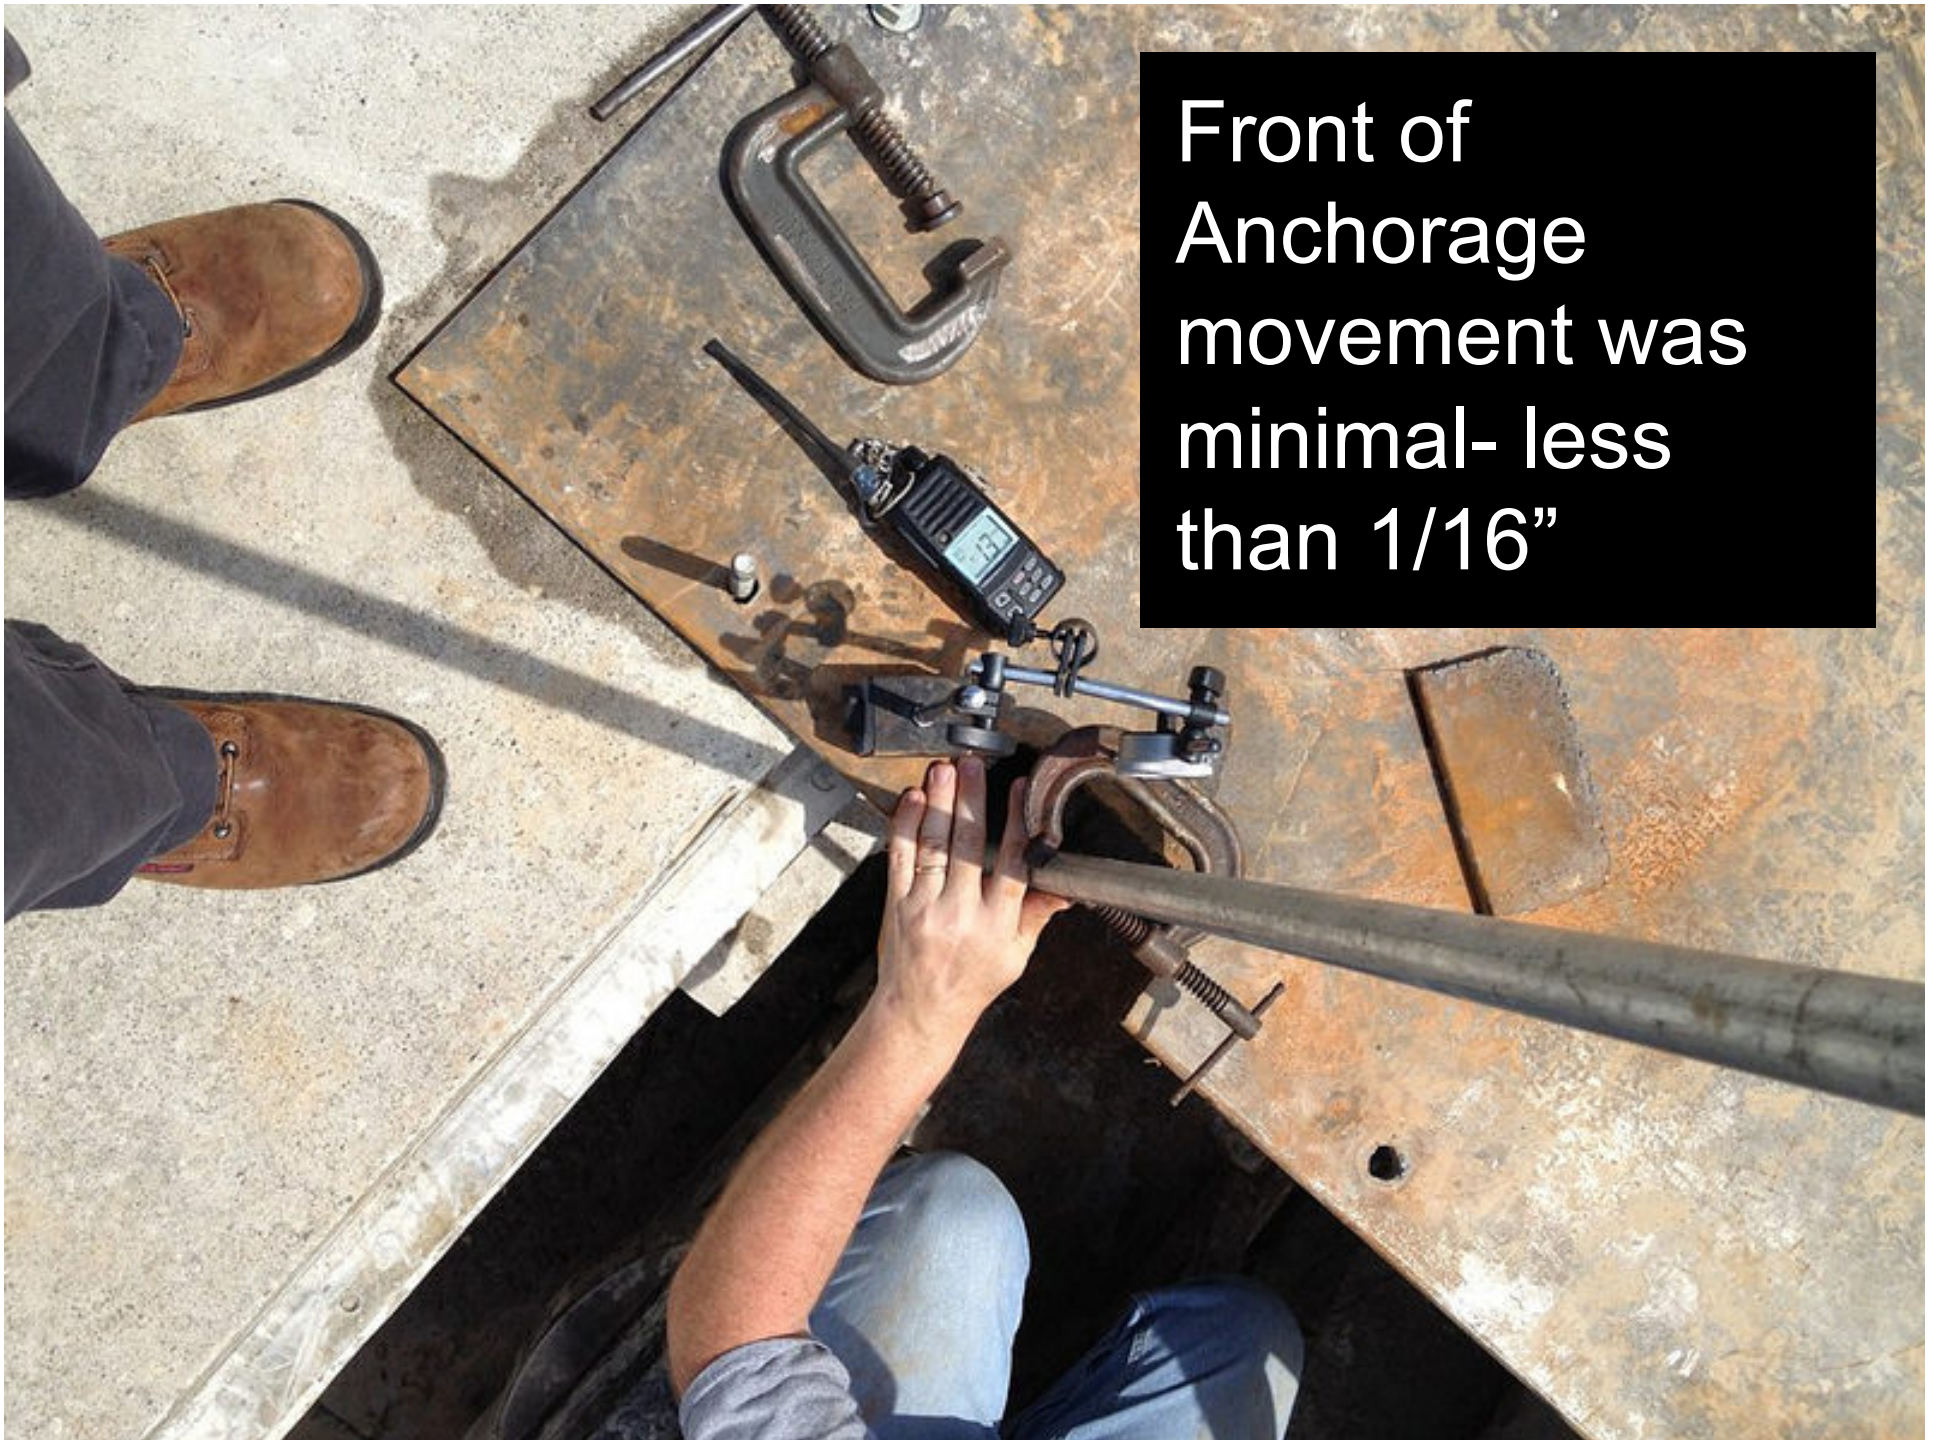
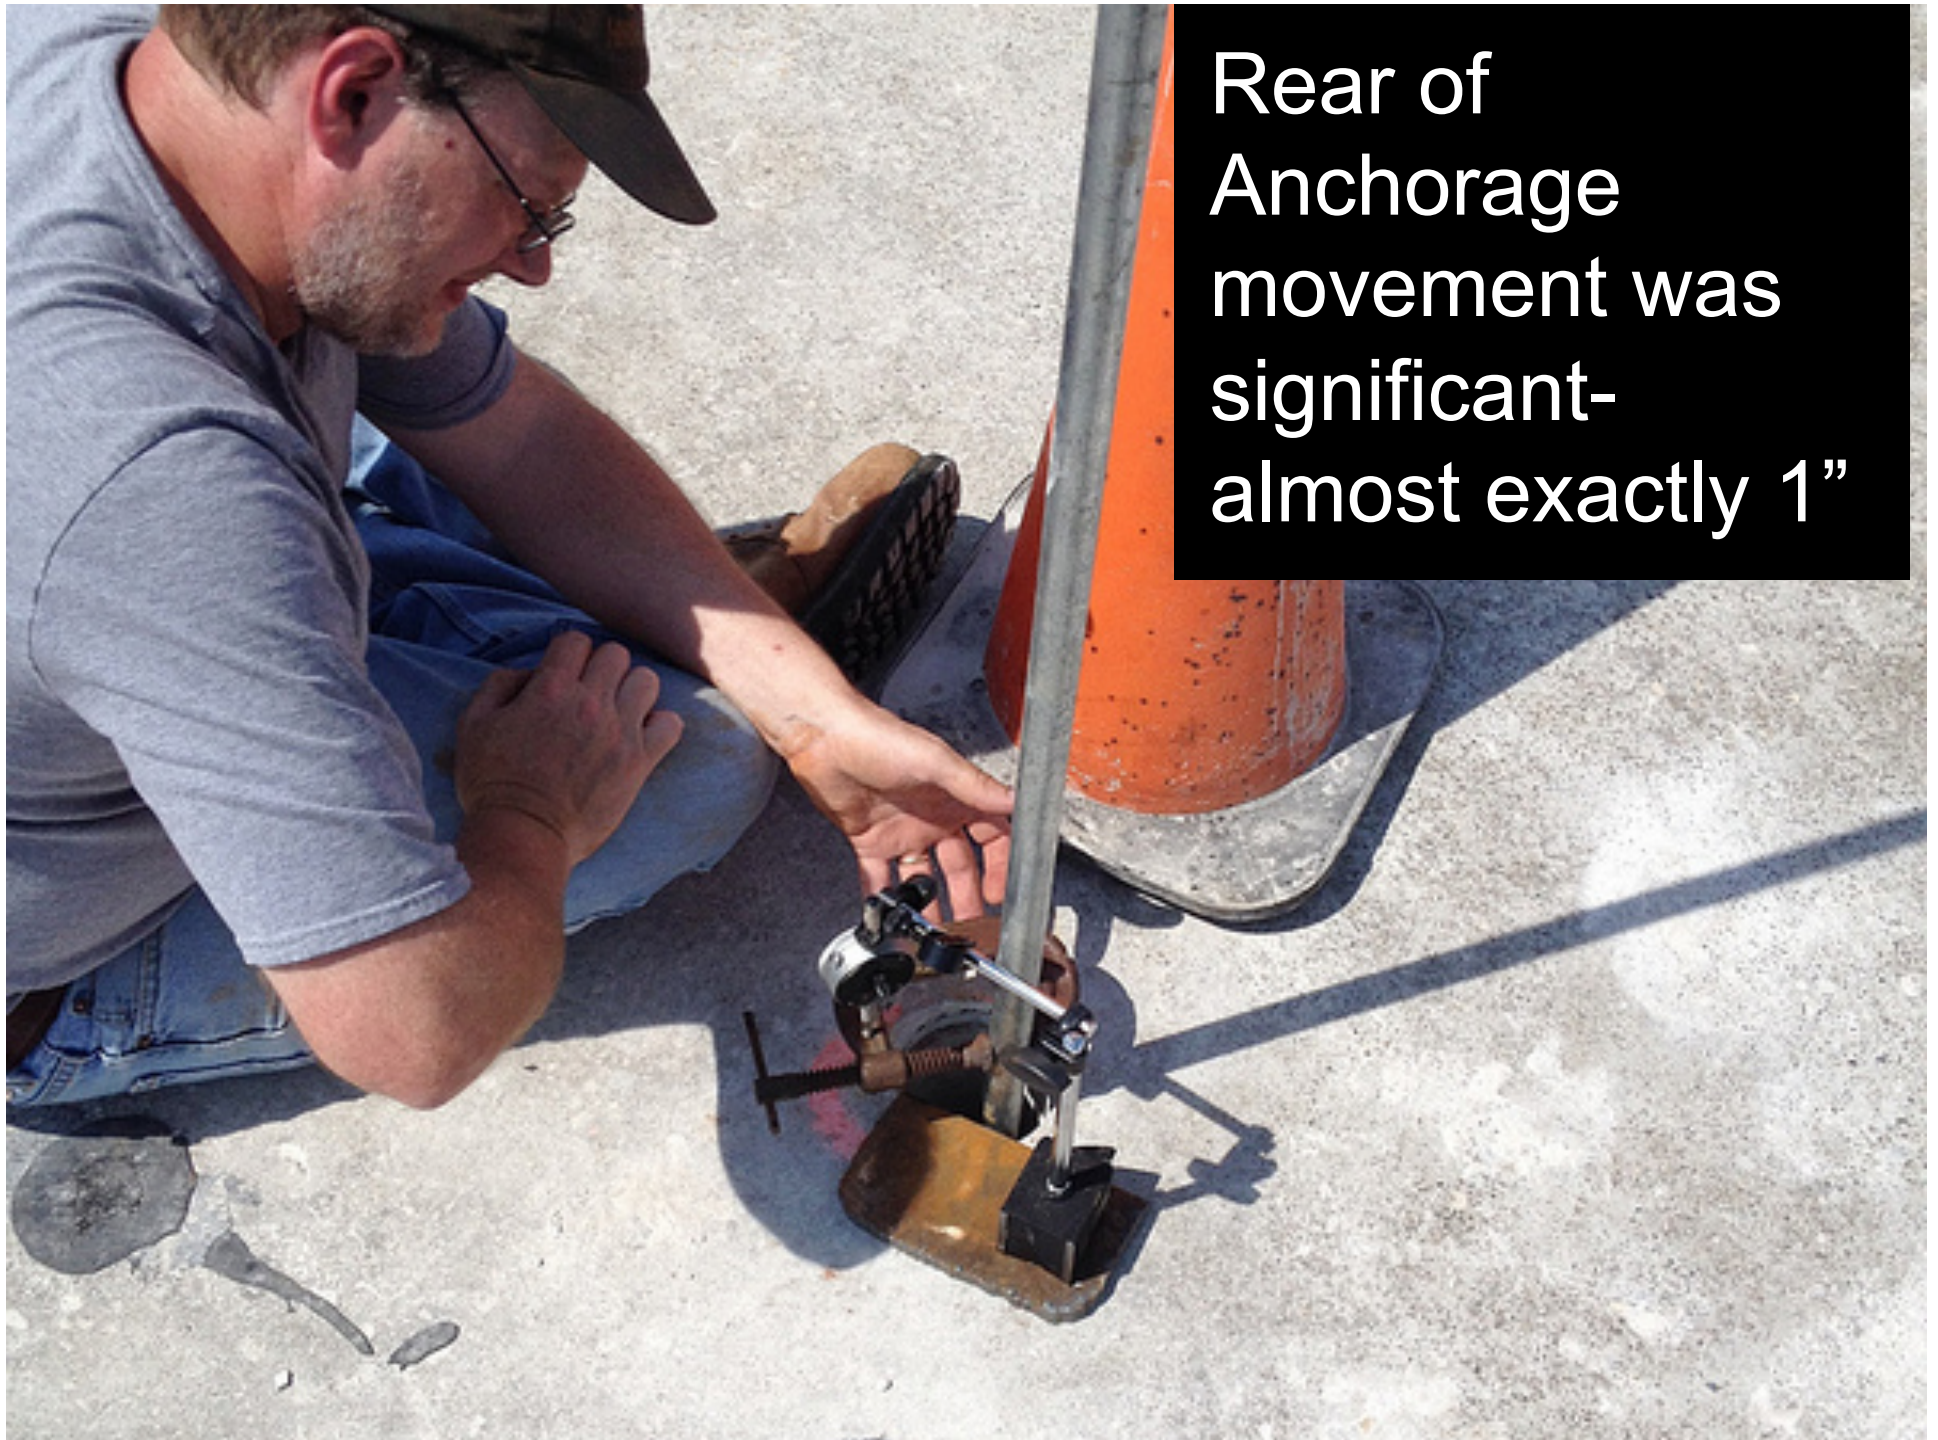
Rear of  
Anchorage  
movement was  
significant-  
almost exactly 1"

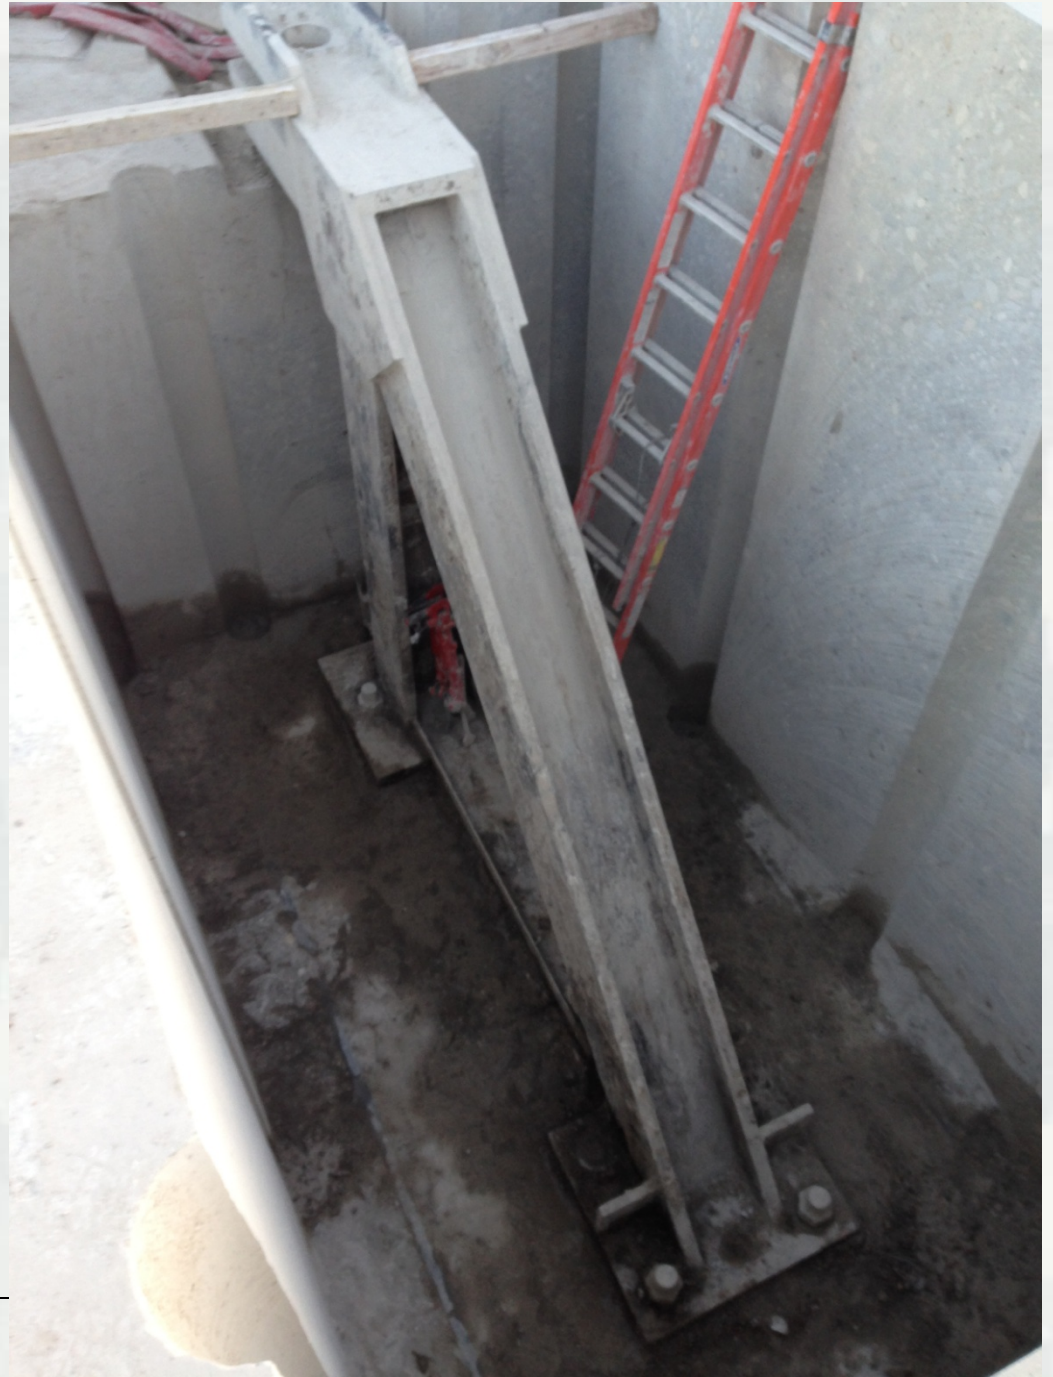
Once roughly 53 cubic yards of concrete was removed from around the embedded anchorage we found there were multiple broken anchorage bolts on the rear of the anchorage

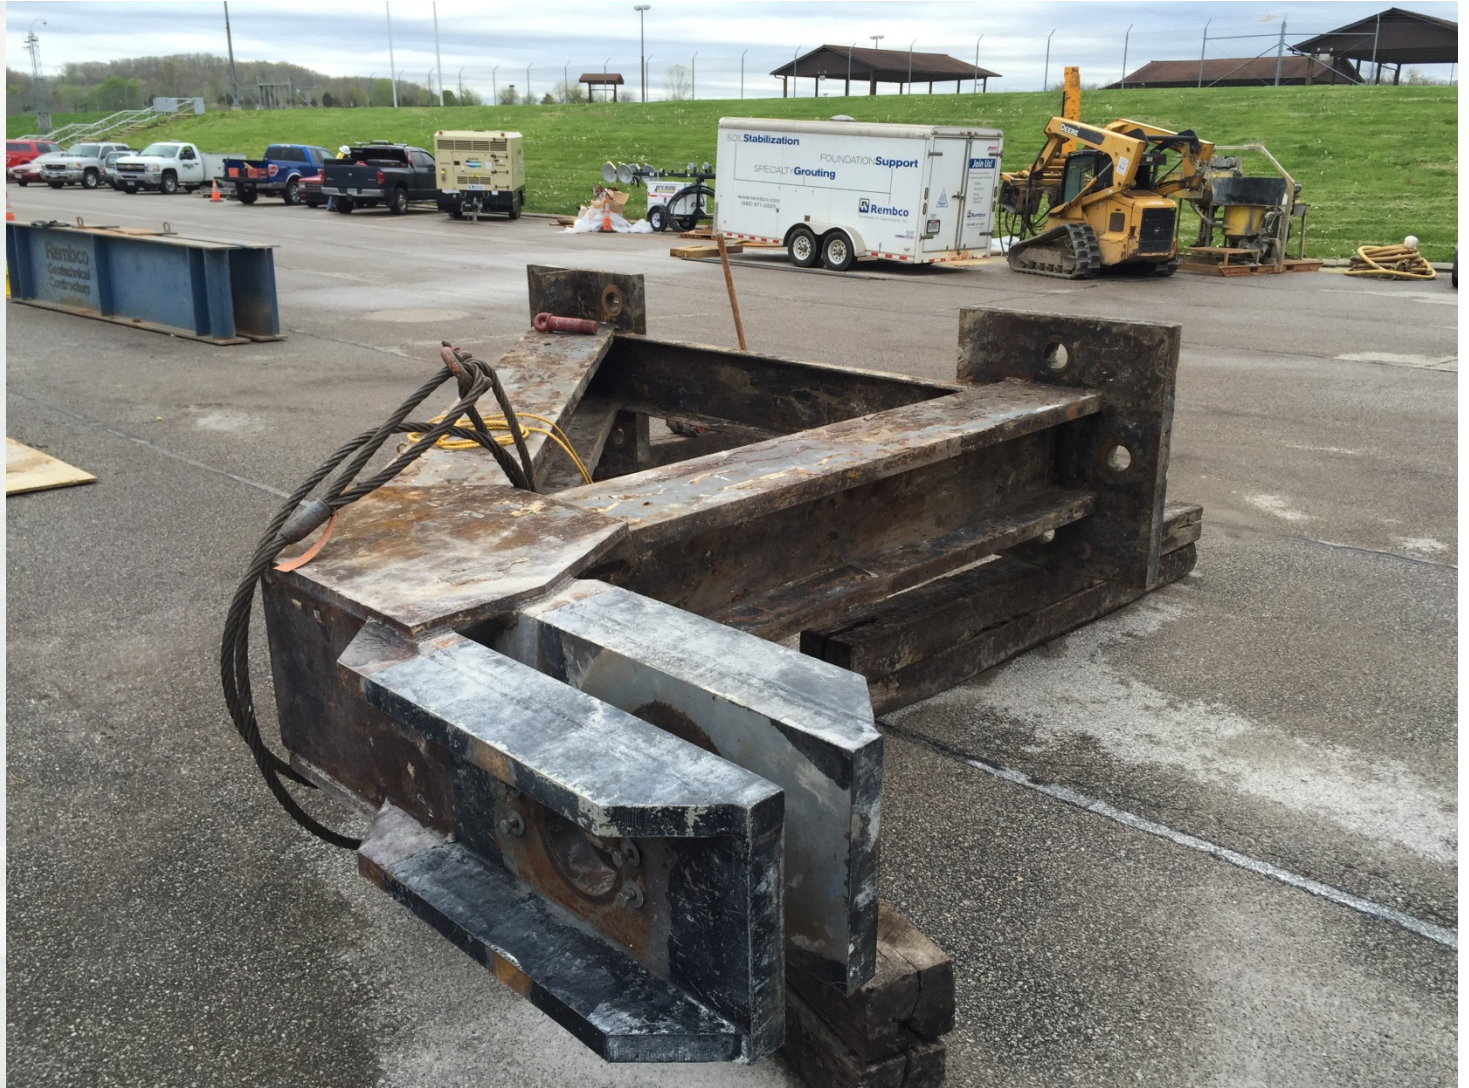
The embedded anchorage weighed approximately 14K pounds.
